91V-137 (1)

Subject: Recall Campaign MBNA Number 91-0913
NHTSA Number 91V-137
Replacement of Parking Brake Grip - 190 Model

Campaign No. 91-0913

SUBJECT: MODEL 201
REPLACEMENT OF PARKING BRAKE GRIP

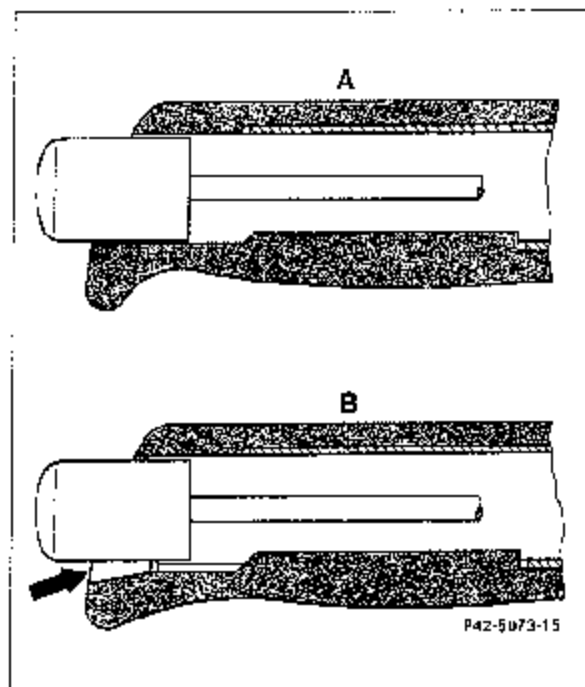
Figure 1

This campaign is initiated because MBNA has found that the grip for the parking brake lever in the subject vehicles produced up to the end of 1987, under certain conditions, can pinch and hold the release knob while the lever is being raised to apply the parking brake. When the release knob is pinched by the grip, it can prevent complete engagement of the parking brake mechanism.

As of the beginning of 1988, a modified grip is installed with greater play in the release knob area (arrow, Figure 1), effectively preventing the grip from pinching the release knob when raising the parking brake lever.

A Grip installed up to end of 1987

B Grip installed as of beginning of 1988

The modified parking brake grip must be installed in all vehicles built prior to the beginning of 1988 within the Effective Serial Number Range on page 2.

1. Remove old grip from parking brake lever by twisting slightly and pulling off. Make sure that the cover on the lever stays clipped onto the hook of the lever.
2. Without using any lubricant, push new grip onto lever by twisting it back and forth until grip almost reaches stop on plastic cover of hand brake lever.
3. Using the old grip as an aid, drive new grip onto lever until it reaches the stop.
